# CONNEXUS

### CASE STUDY FOR 698 RIVETLESS CHAIN

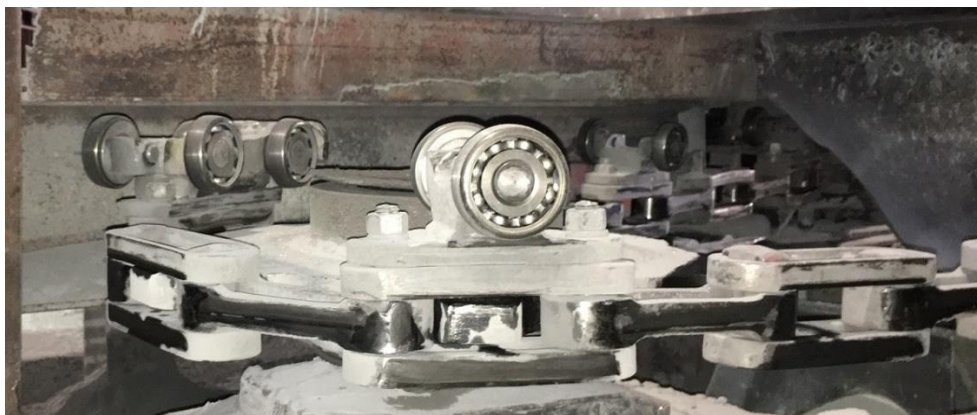
A carriage assembly is attached to the extended pins which suspends the chain around the conveyor.

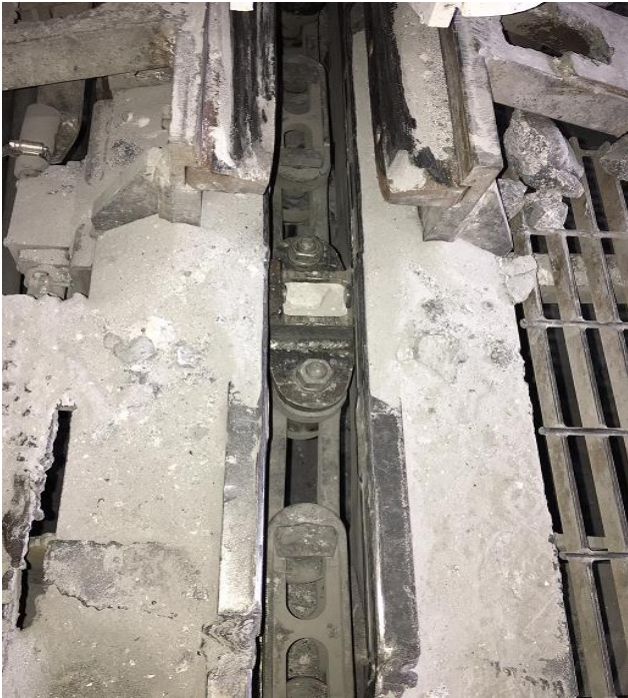
The chain runs in a channel with extended pins vertical.

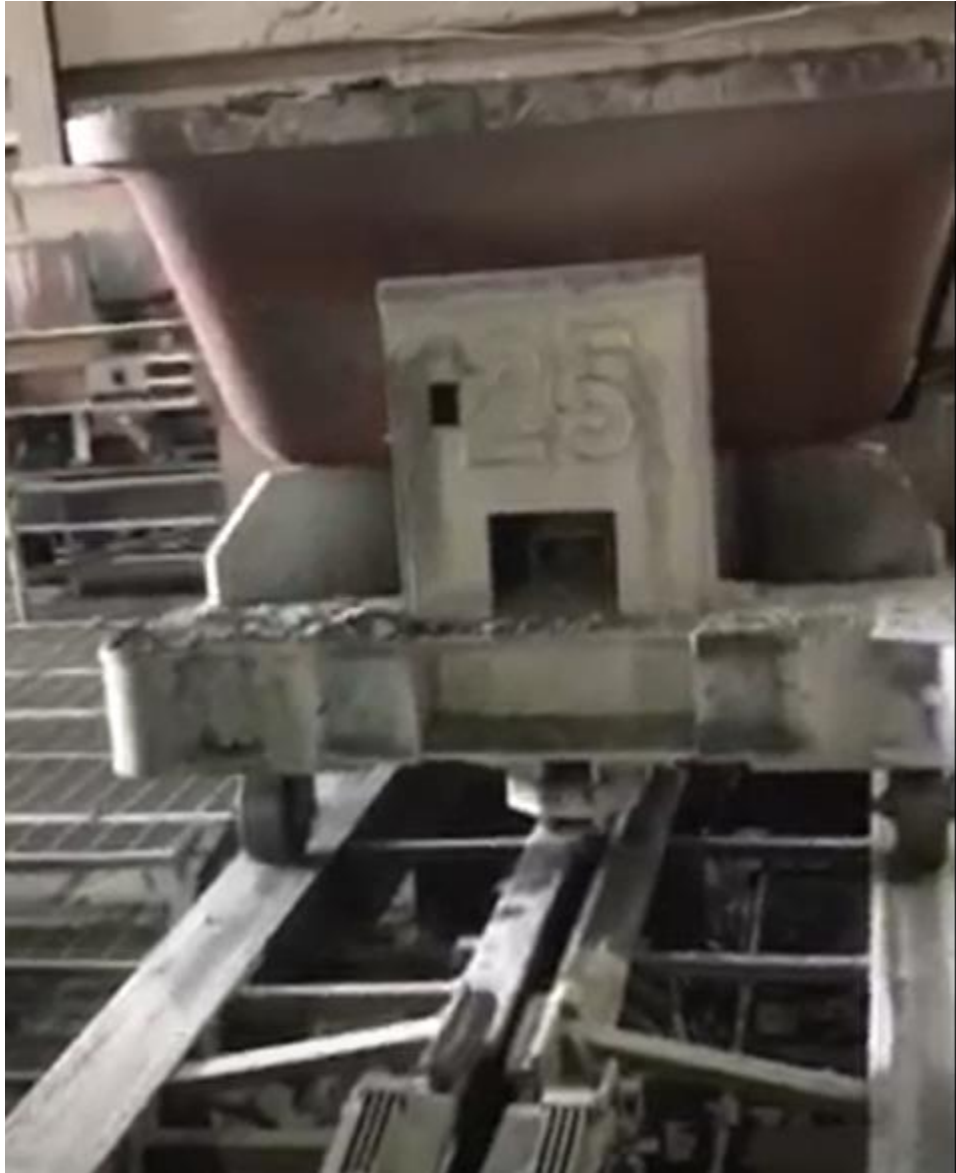
**The chain engages a cart which weighs 14,000 pounds and travels at 100FPM. Up to 7 carts can be engaged on the chain at one time.**

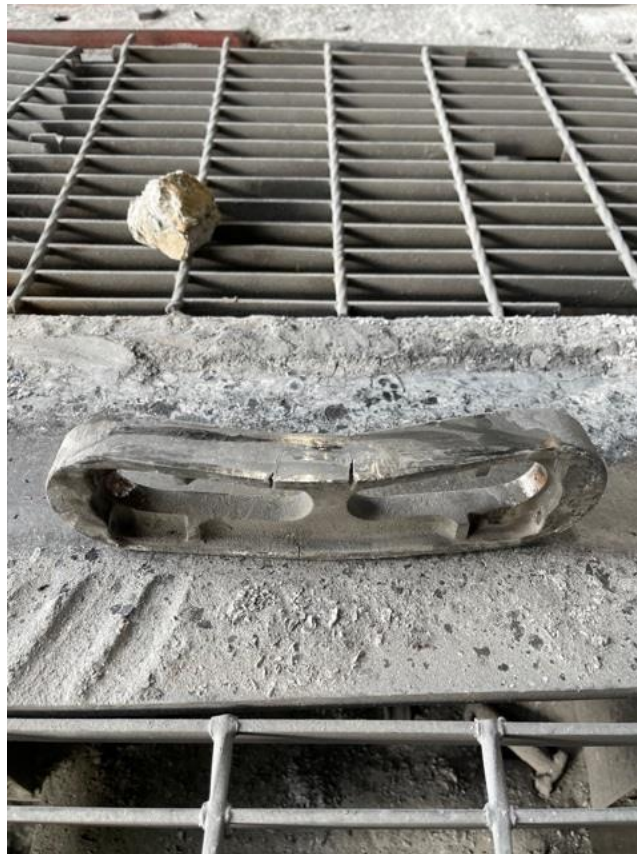
Previous chains have stretched and broken links constantly, within days of installation.

Customer worked with many chain suppliers but could not get a chain that would hold up in this difficult application, experiencing failure rates on at least 5% of the links.

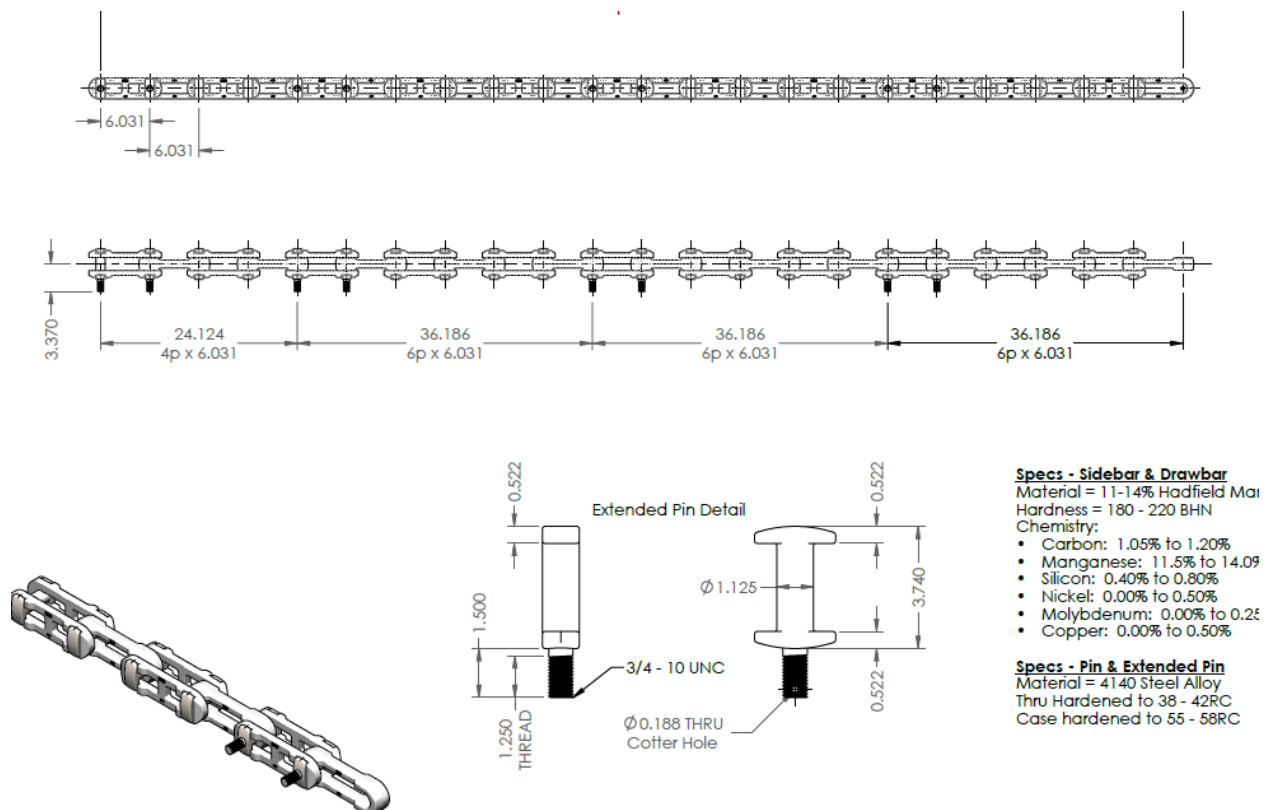
### OUR CXS 698 HADFIELD MANGANESE CHAIN W/EXT PINS E6P.

**“CXS” Hadfield Manganese Chain is the best choice for this application due to its’ ability to endure severe impact. This, combined with the ability to work-harden into the range of 500-600BHN makes this chain an excellent choice for this application.**

Since installation in May, they have removed only one link and have had zero breaks.
